**REHABILITATION OF THE MANSOUR
PUMP STATION**

UNDER THE COMMANDER'S EMERGENCY RESPONSE PROGRAM

BAGHDAD, IRAQ

**SIGIR PA-07-111
JANUARY 24, 2008**

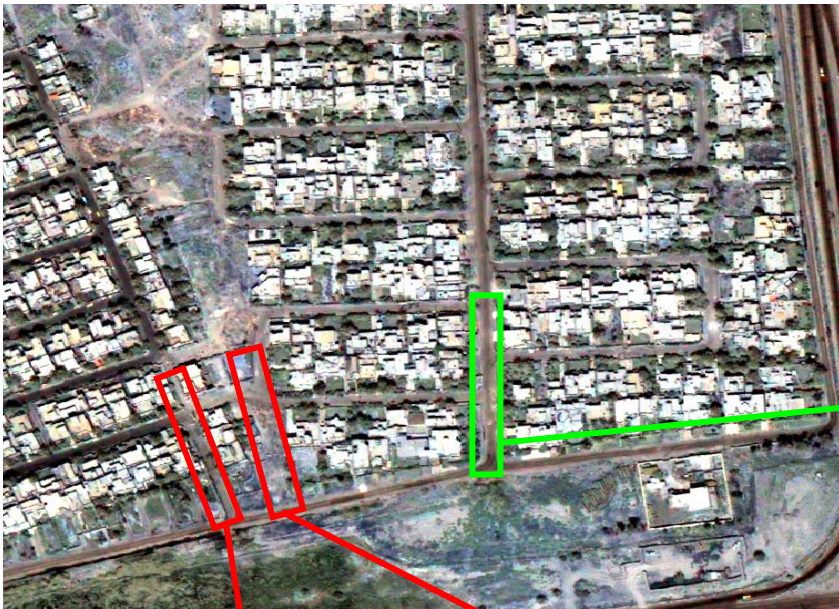
During our first site visit, we identified streets in the Al Amerea area with backed up sewer water and streets with no sewer water back up (Aerial Image 2 and Site Photos 9-11). While we conducted our site visit, a concerned resident of the area angrily complained about the backed up sewer water on his street.

Aerial Image 2. Overview of the Al Amerea area
(Provided by Digital Globe 2007 ©)

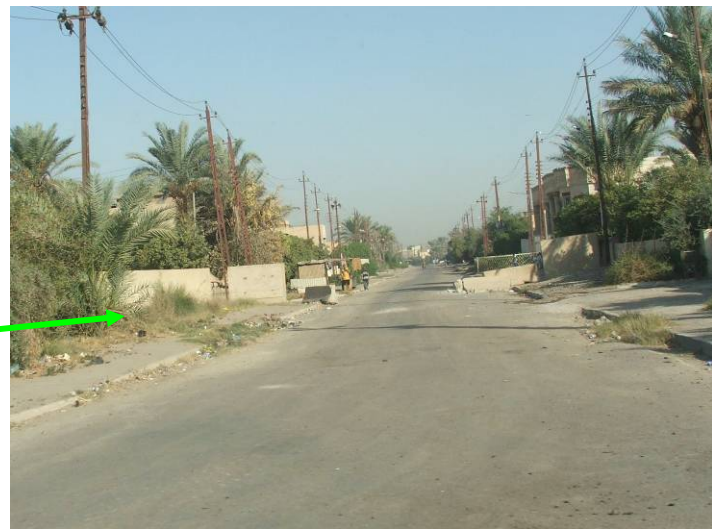
Site Photo 9. Neighborhood street in Al Amerea

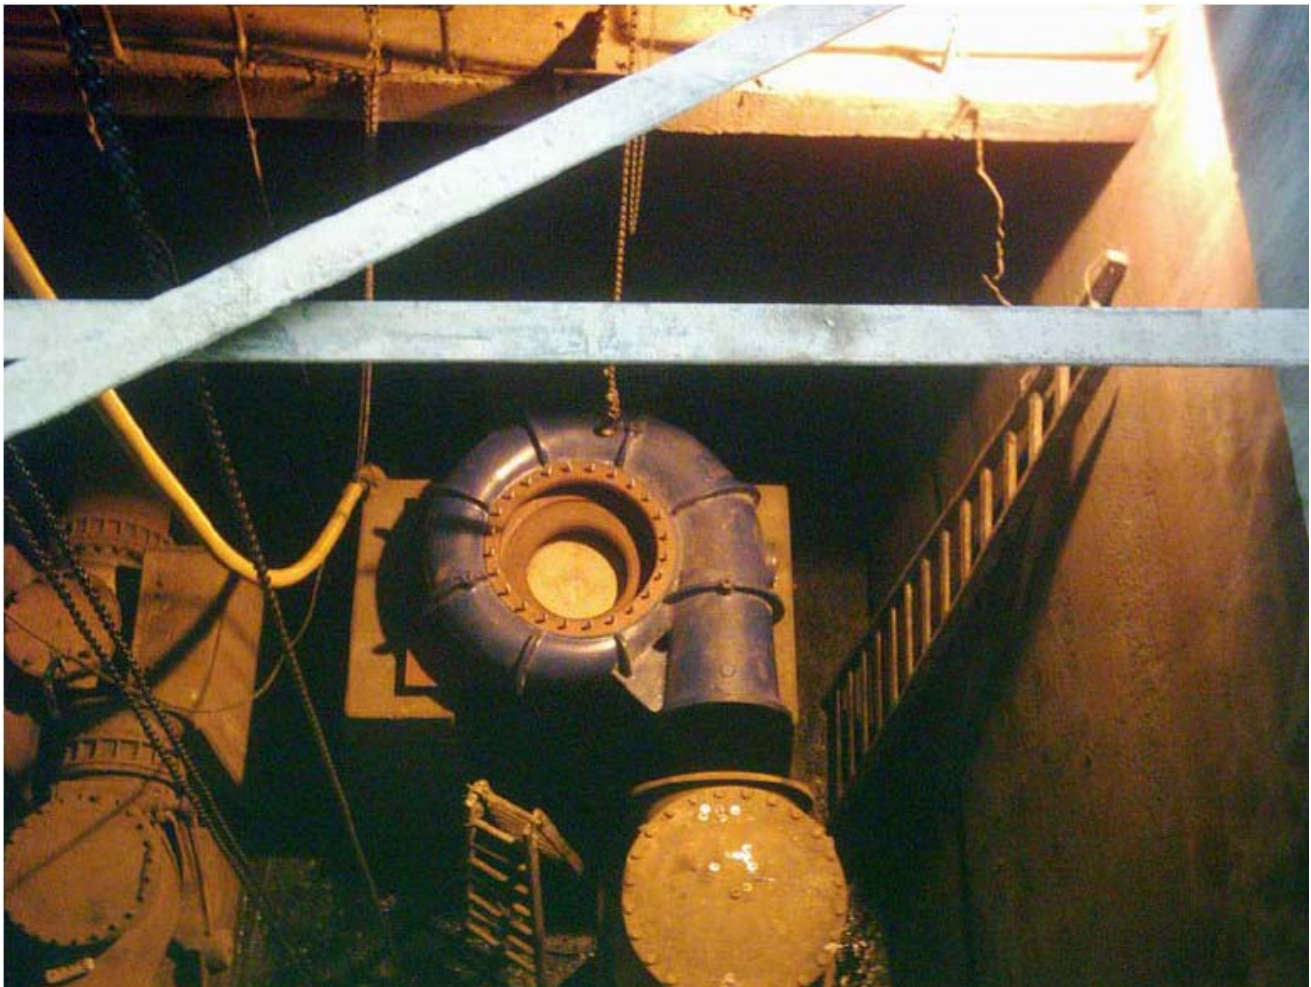
Phase 2 contract file documentation showed photographs of the installation of the four vertical pumps. For instance, Site Photo 21, which shows the installation of the 800 mm vertical pump, came from a daily QAR report.

During our site visits, we identified significant amounts of rust on the bottom of all four vertical pumps and the nuts and bolts connecting the vertical pumps to the outlet pipes. For example, in the case of the 800 mm vertical pump, the bottom of the pump is severely rusted as well as the nuts and bolts connecting it to the outlet pipe (Site Photos 23 and 24). There are only two possible reasons to explain the significant amount of rust on the bottom of the newly installed vertical pumps – either the pumps installed were used (and previously rusted) or the contractor did not properly install the vertical pumps. Poor installation of the vertical pumps would result in water overflowing the pump causing rust to form.

Site Photo 21. Photograph from daily QA report documenting contractor progress installing the 800 mm vertical pump (Photo courtesy of the USACE)

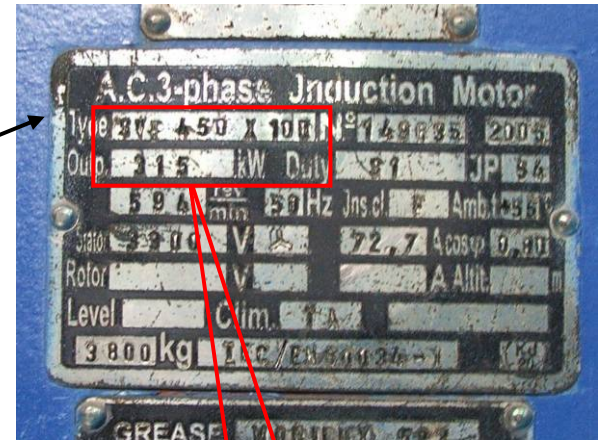
During our site visit, we recorded the vertical pump motor information to compare against the contract file documentation to determine if new motors had been installed (Site Photos 27 and 28 and Figure 3). Subsequent to the issuance of the draft report, the GRD officials provided a list of the serial numbers for the vertical pumps and motors. For example, we determined that the 800 mm vertical pump motor serial number matched the GRD's documentation.

Site Photo 28. Face plate for vertical pump motor
